**FINAL REPORT
ROUND 7 DAM ASSESSMENT - WISCONSIN POWER & LIGHT
COLUMBIA GENERATING STATION
PRIMARY ASH, SECONDARY ASH, POLISHING & LANDFILL
STORMWATER PONDS
PARDEEVILLE, WISCONSIN**

June 2, 2011

Re: Round 7 Dam Assessment - Final Report
EPA Contract No. EP10W001313
Wisconsin Power & Light – Columbia Generating Station
Primary Ash, Secondary Ash, Polishing & Landfill Storm Water Ponds
Pardeeville, Wisconsin

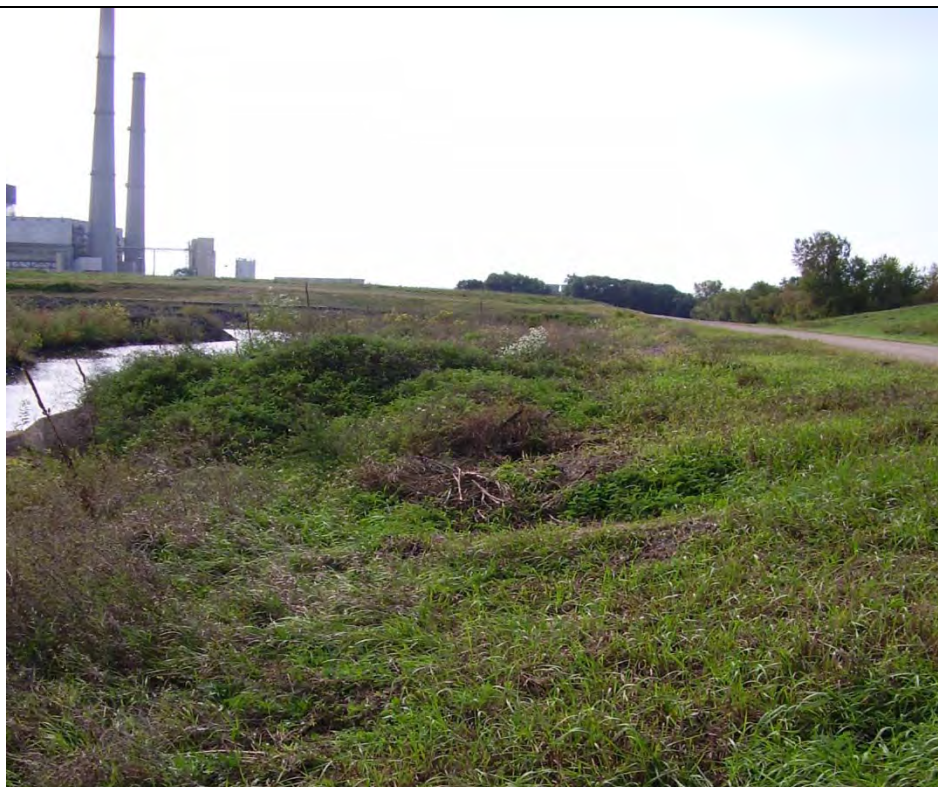
Photo No.
1

Description:
Upstream slope of PAP.

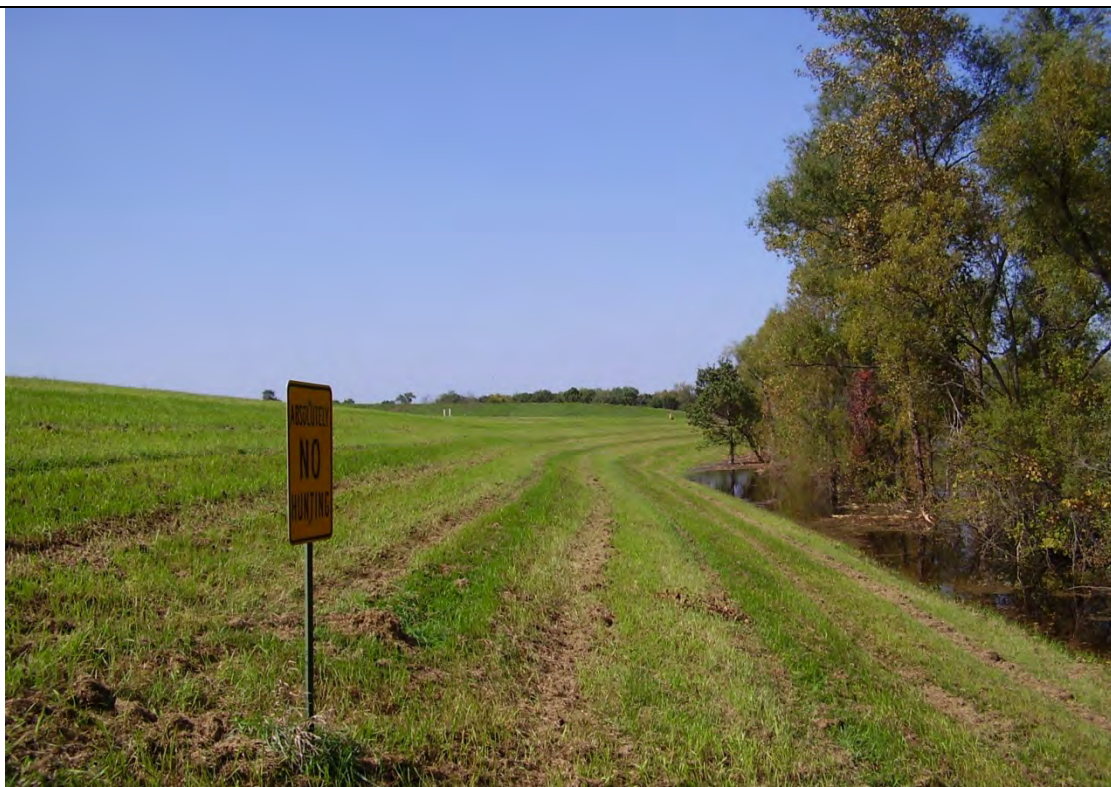
Photo No.
24

Description:
Downstream slope of PAP

GZA has revised Section 2.1.4 to state: *During our Site visit, the floodwaters of the Wisconsin River backed up into Duck Creek and covered the downstream toe and part of the northern embankment as shown in Photos 24 through 26.*

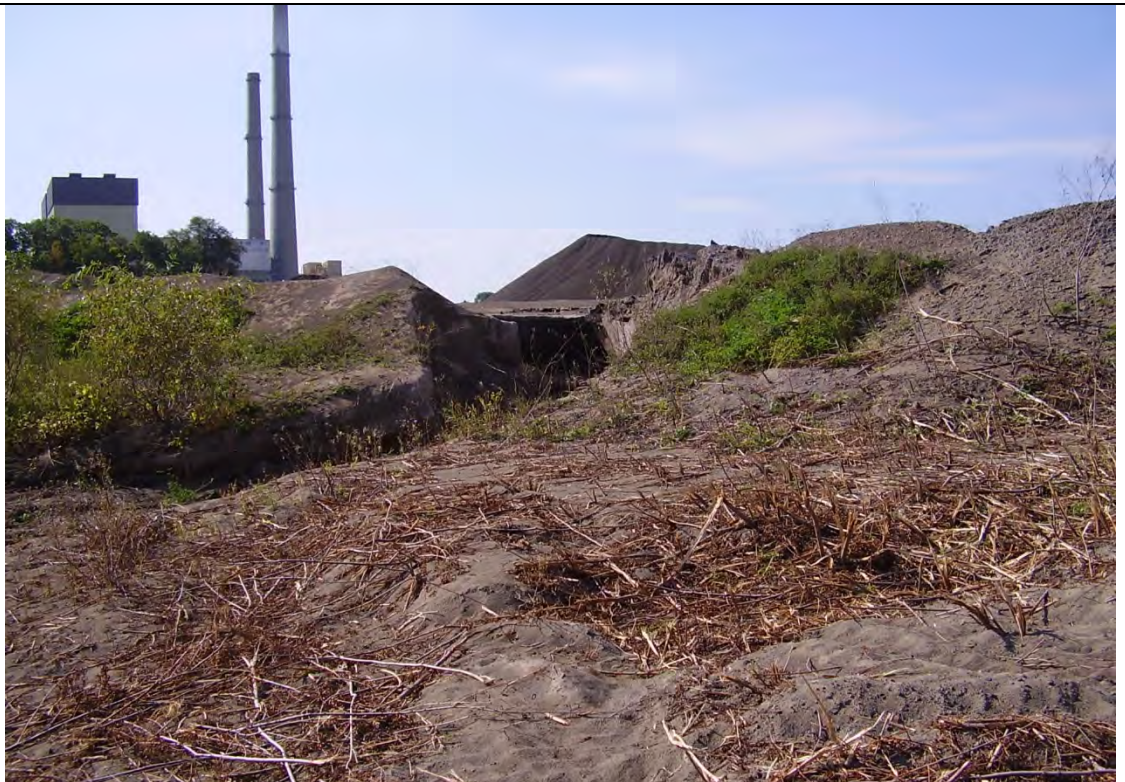
Photo No.
34

The impoundment is incised along the western and southern embankments. An embankment separates the PAP from the SAP such that the eastern embankment downstream slope of the PAP is the same as the western embankment upstream slope of the SAP. During our Site visit, the floodwaters of the Wisconsin River were backed up into Duck Creek and covered the downstream toe and part of the northern embankment as shown in Photos 24 through 26. The downstream slope of the northern embankment of the impoundment was generally in good condition. The northern embankment was vegetated with grass that appeared to be regularly mowed and trees had recently been removed from the northern embankment as shown in Photo 27. There was minor wave action erosion over much of the eastern embankment downstream slope as shown in Photos 31 and 32. A large ditch that appeared to be formed by stormwater erosion was noted on the downstream slope near the southeast corner of the PAP. The eroded ditch was approximately 10 feet wide, 6 feet to 8 feet deep, and 50 feet long and is shown in Photos 34 and 35.

Description:
Upstream slope of SAP,
downstream slope of PAP,
and large erosional feature.

1. Repair erosion ditches present in the PAP, SAP and LSP.

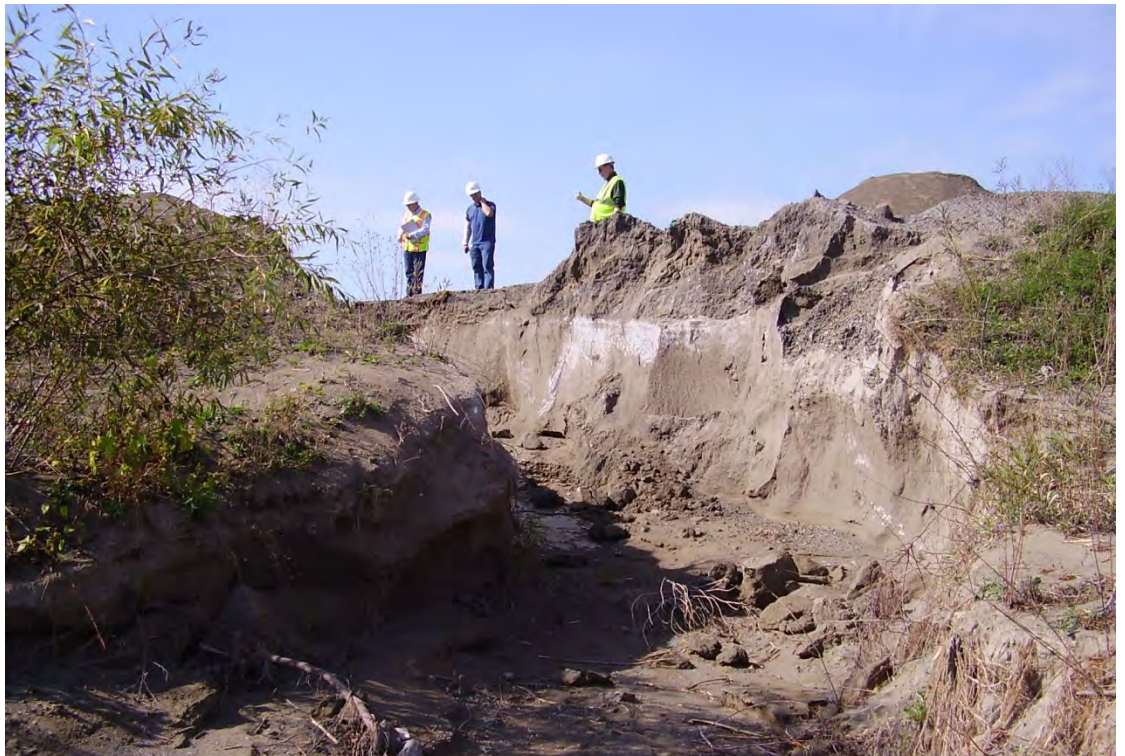
Description:
Erosional feature in SAP.

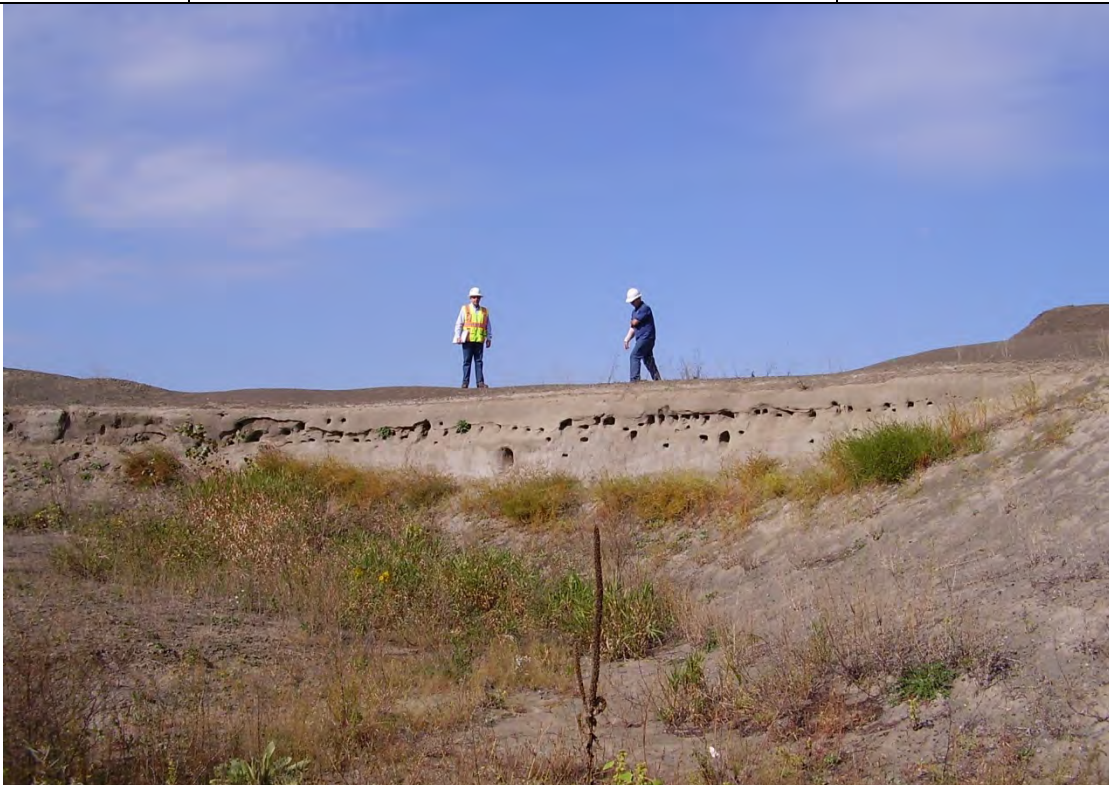
Description:
Downstream slope of PAP
and animals/bird burrows.

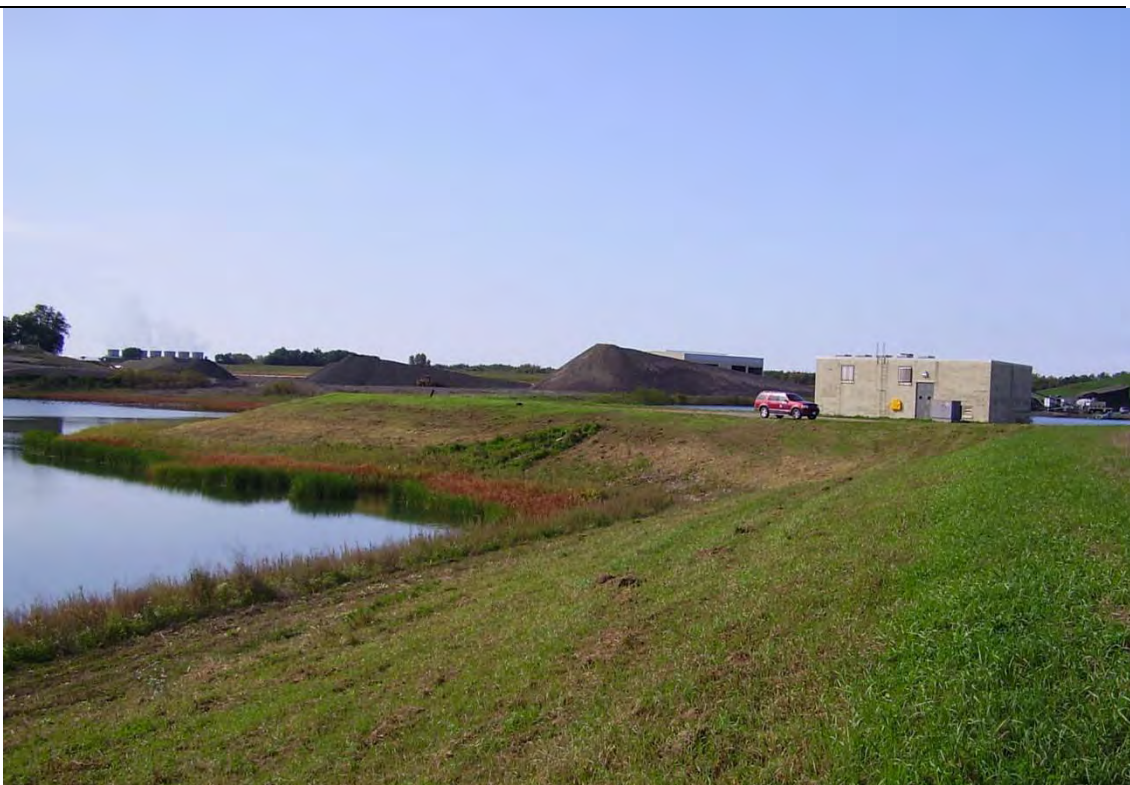
Photo No.
44

Description:
Upstream slope of SAP and
PAP pump house.

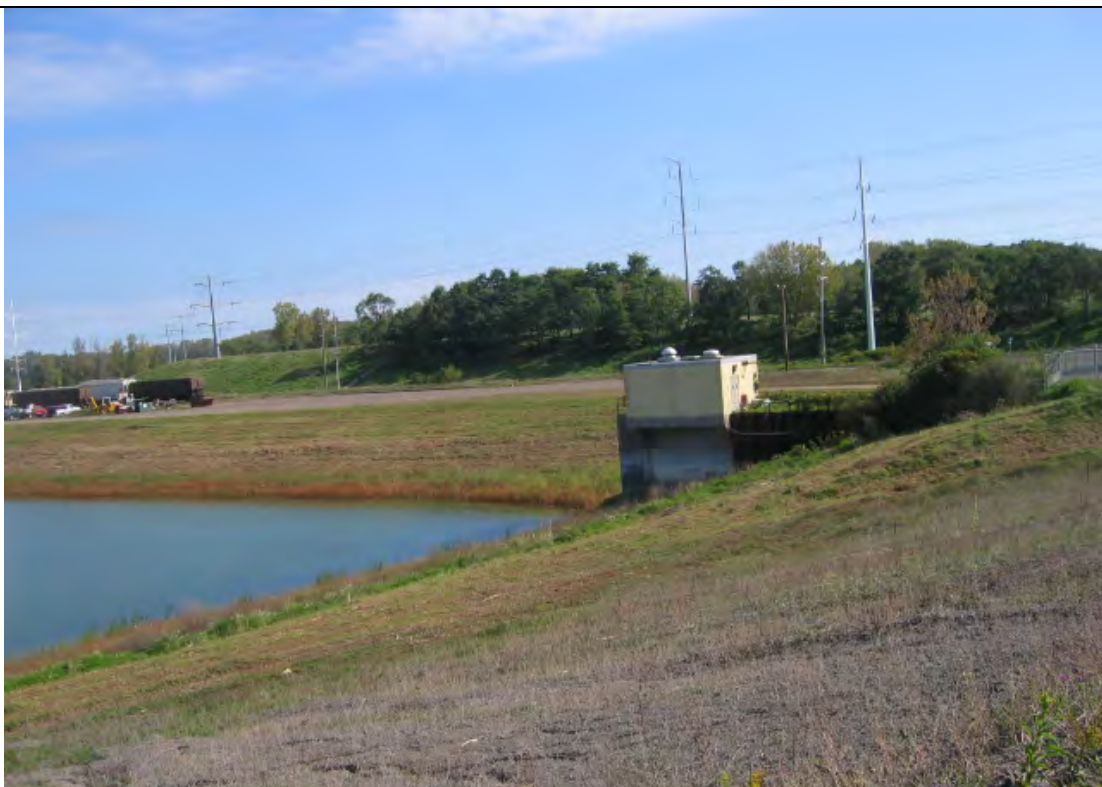
Photo No.
46

Crest of SAP and SAP pump
house.

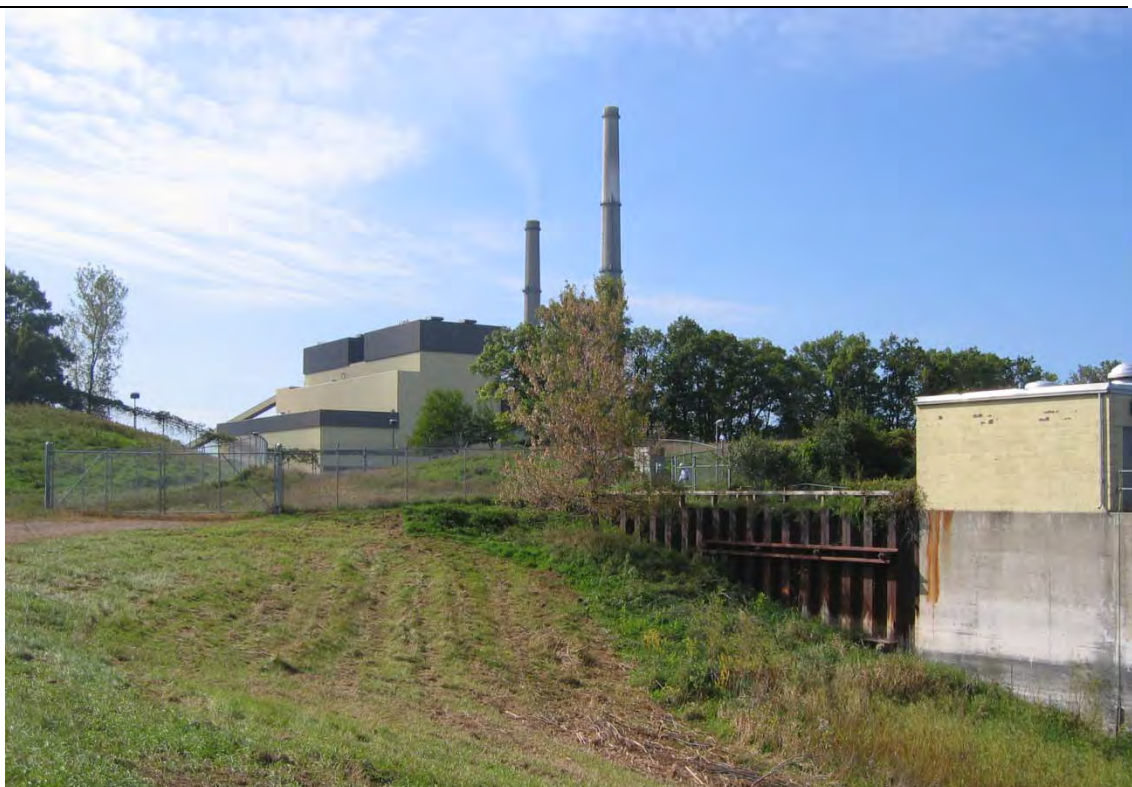
Photo No.
48

Description:
Crest of SAP and SAP pump
house.

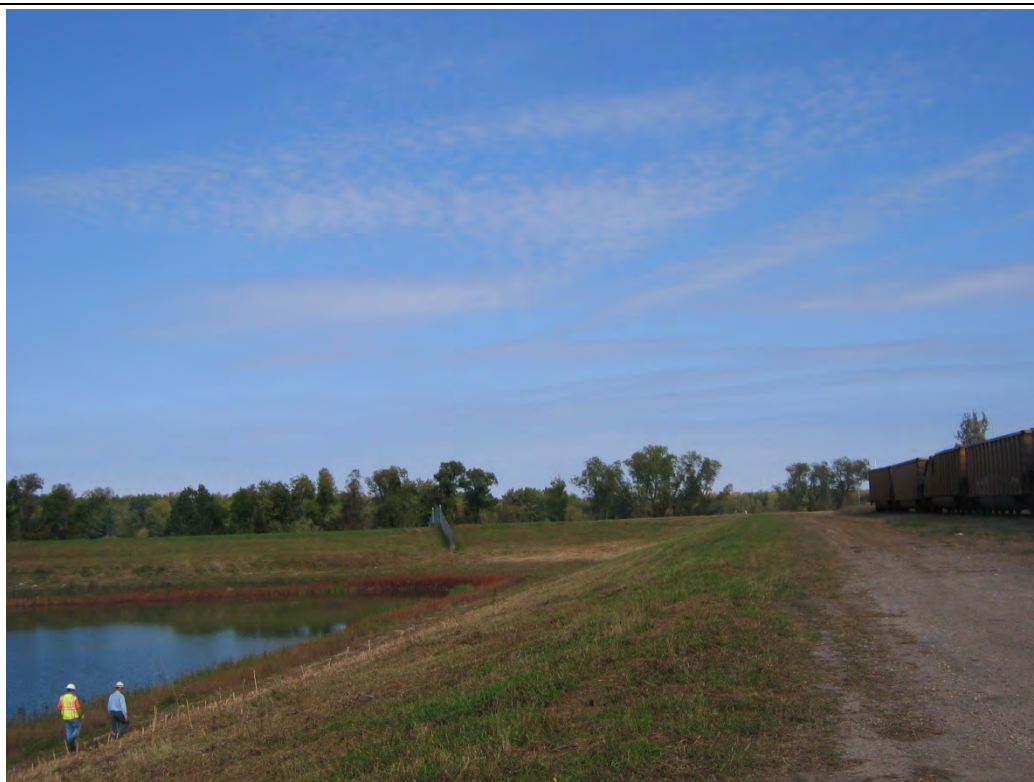
Photo No.
50

Description:
Crest of SAP.

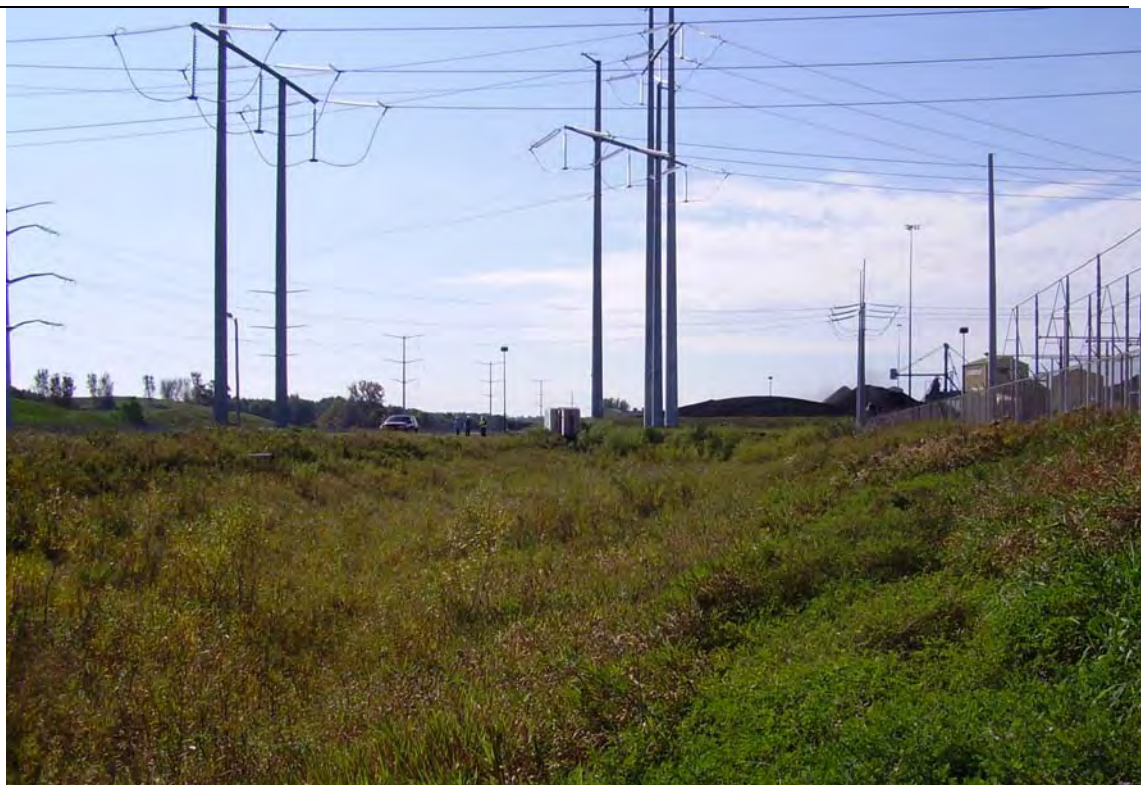
Photo No.
54

Description:
Upstream slope of PP.

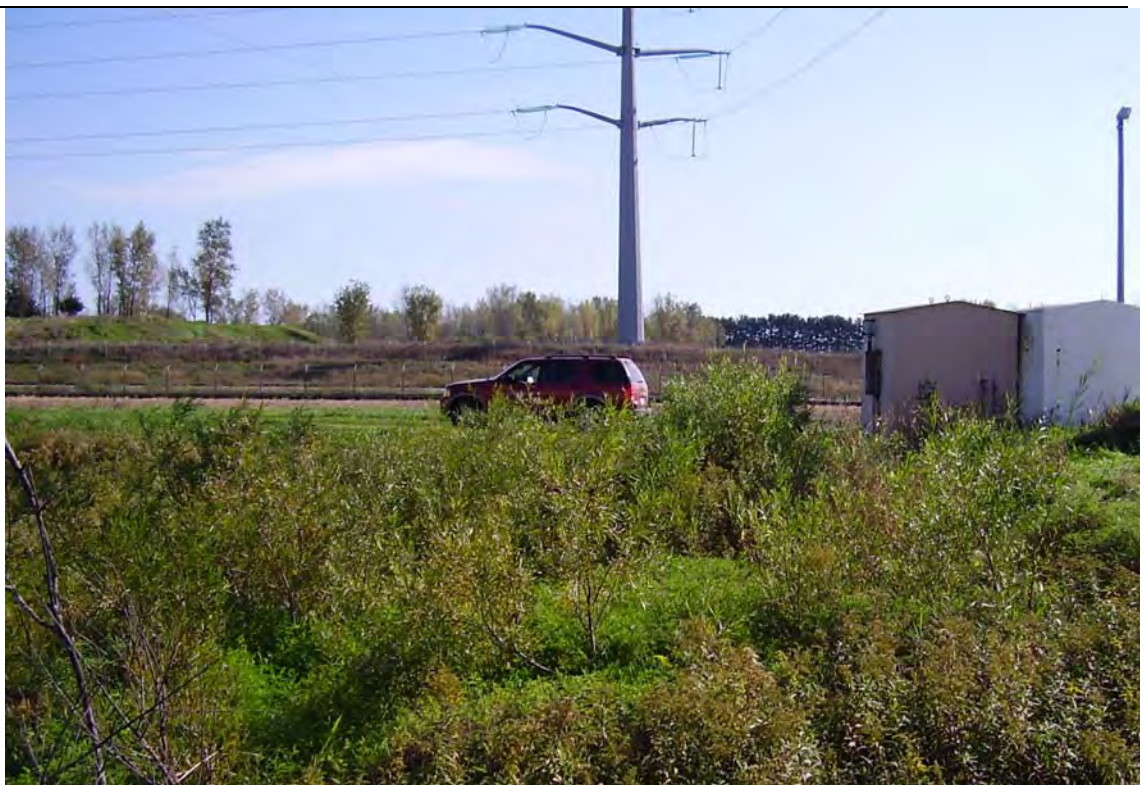
Photo No.
56

Description:
Crest of PP.

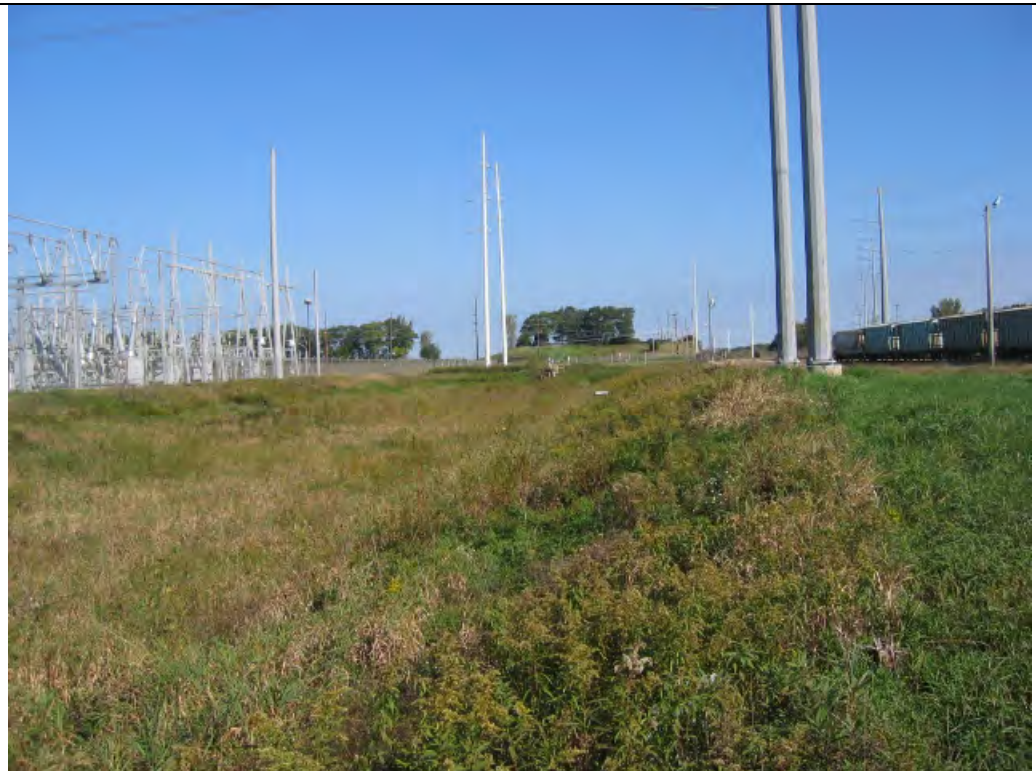
Photo No.
58

Description:
Upstream slope and crest of
PP.

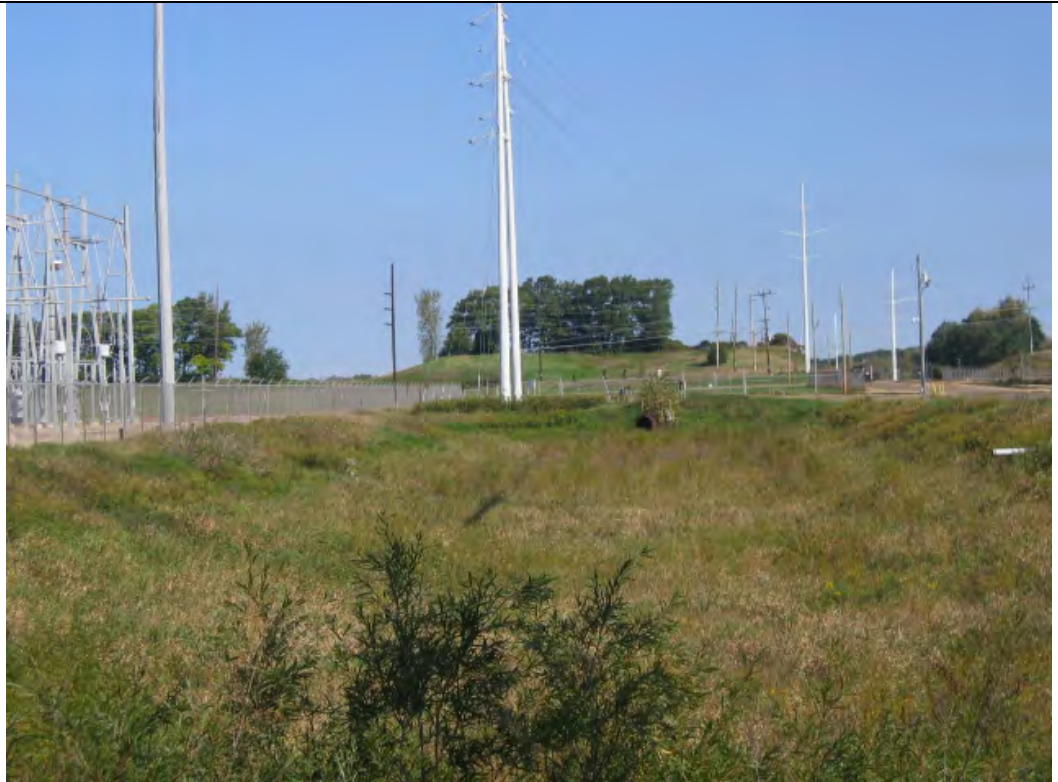
Photo No.
60

Description:
Upstream slope and crest of
PP.

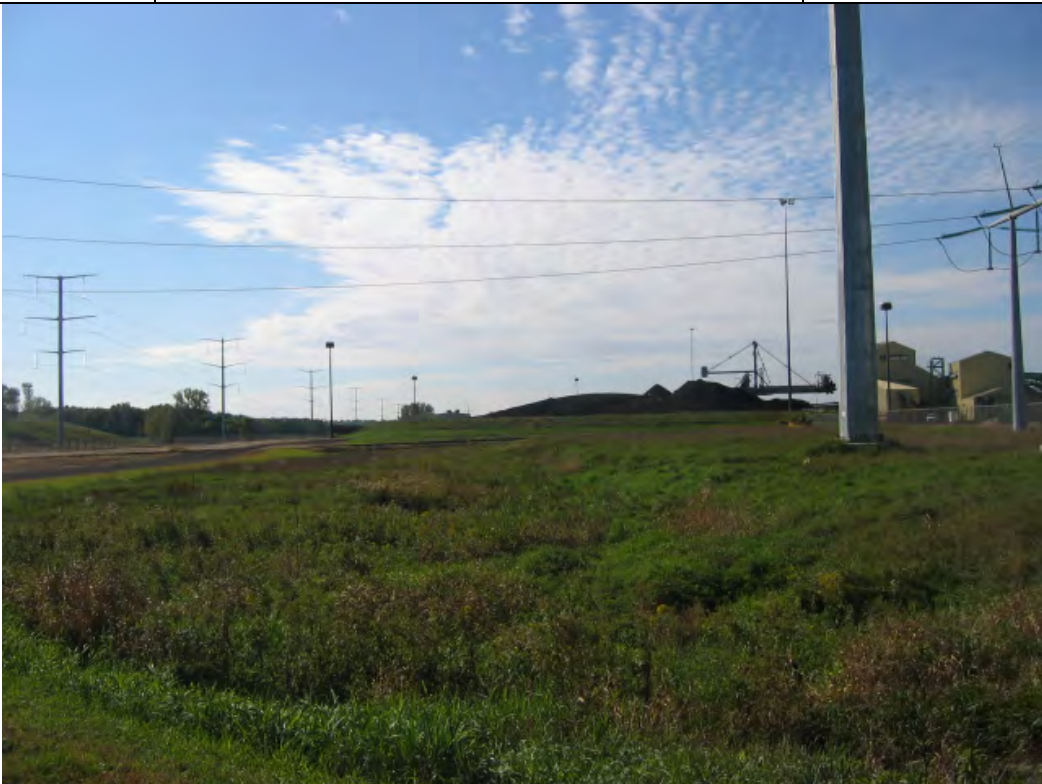
| Description: Drainage ditch south of PP. | | | |

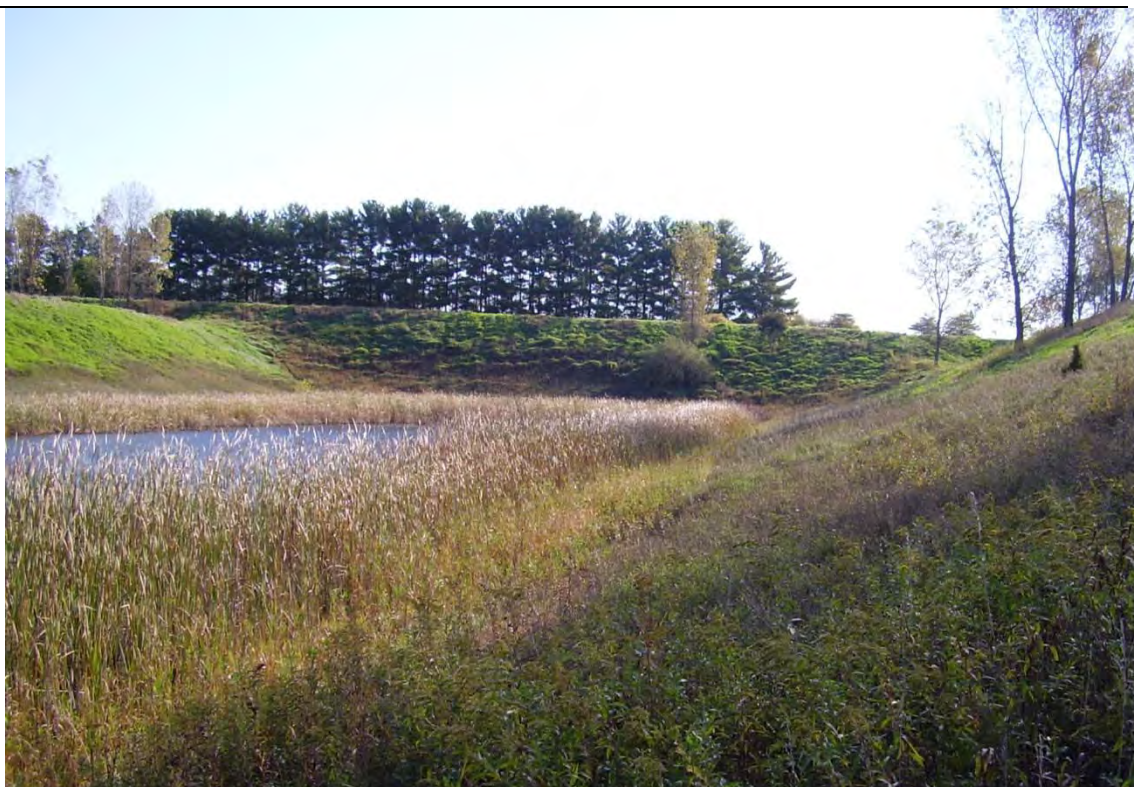
Photo No.
66

Description:
Upstream slope of LSP.

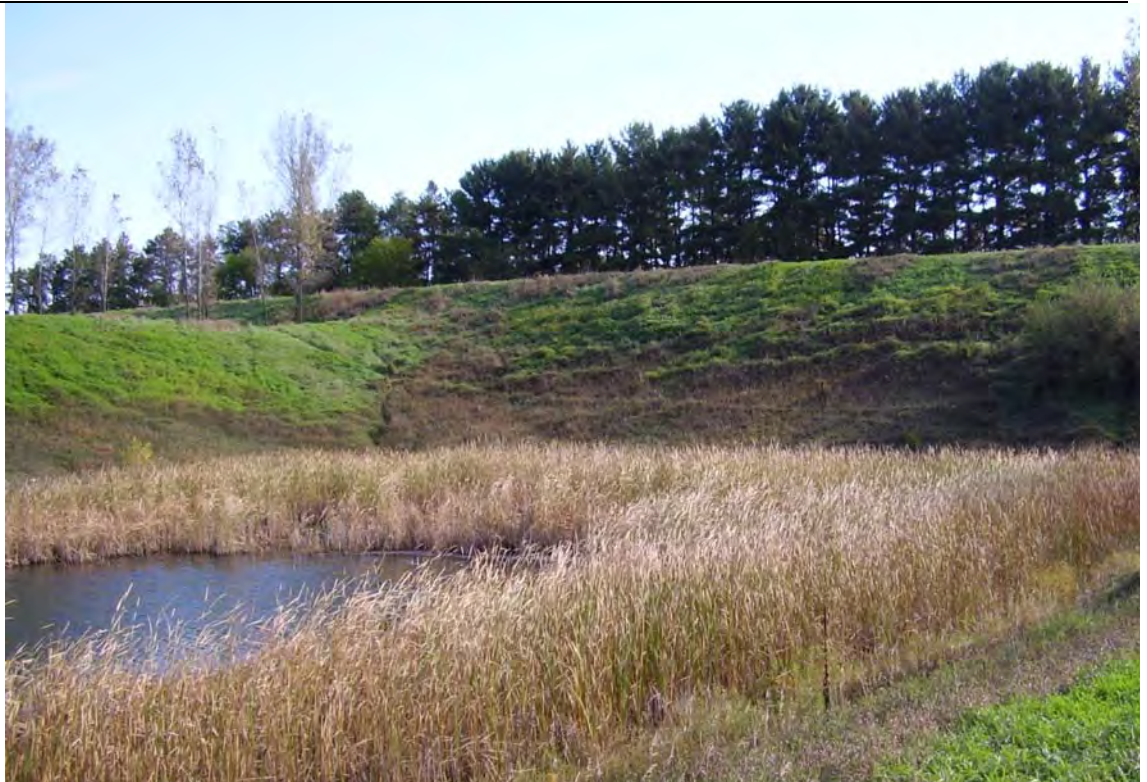
Photo No.
68

Description:
Upstream slope of LSP.

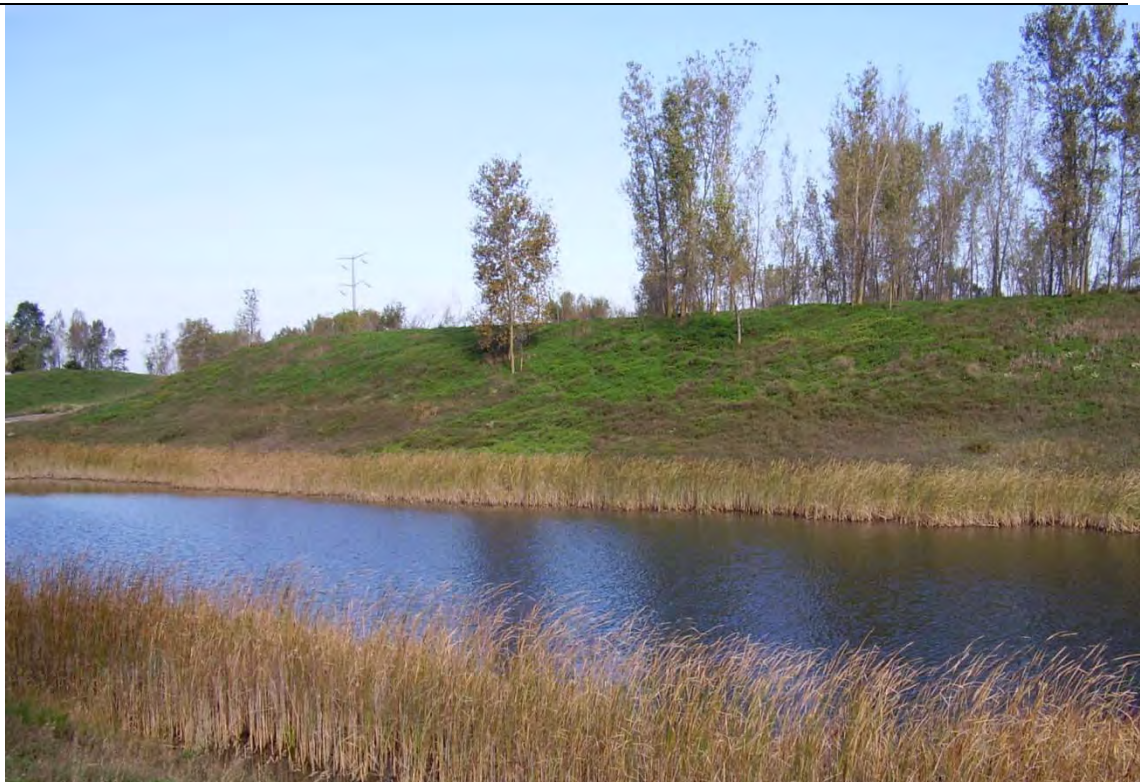
Photo No.
70

Description:
Upstream slope of LSP.

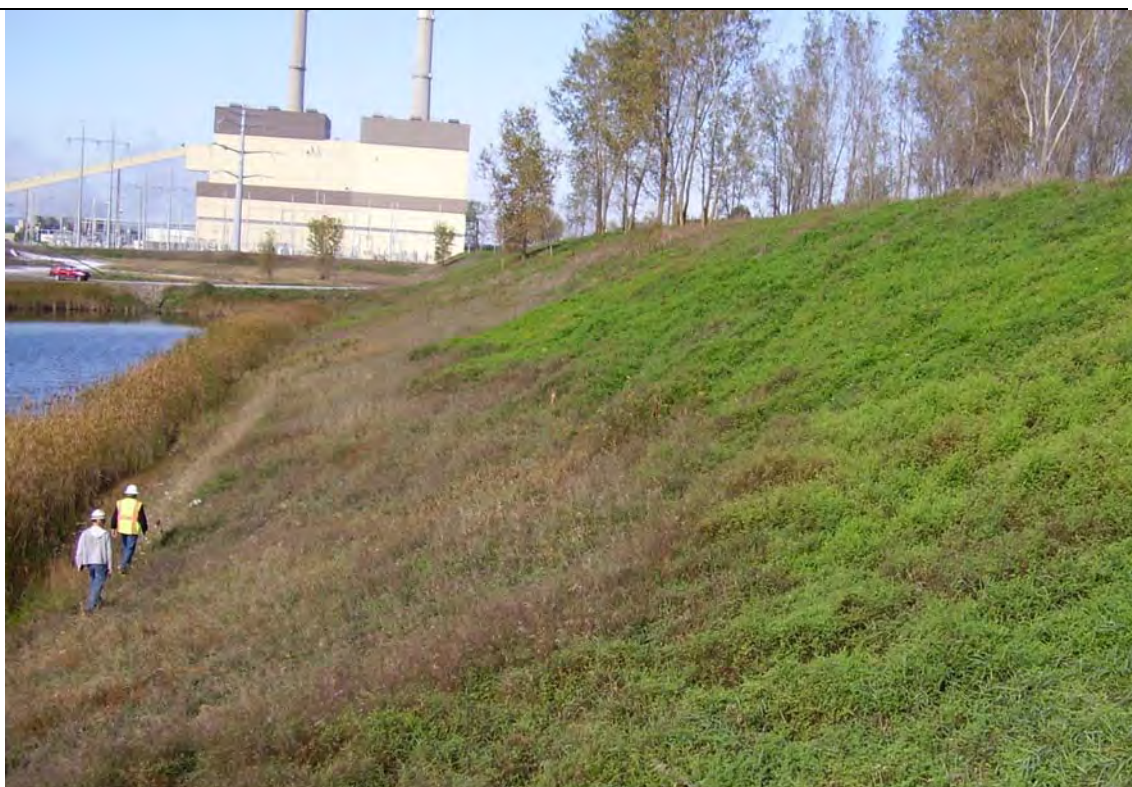
Photo No.
72

Description:
Upstream slope of LSP.

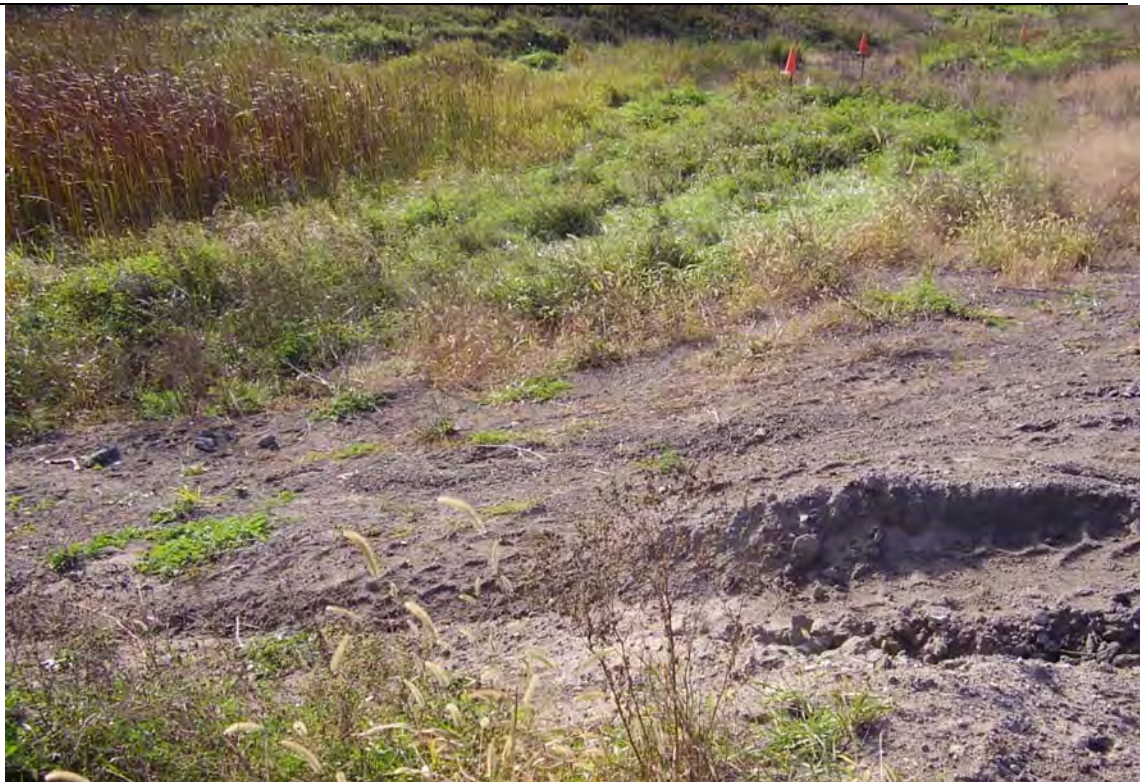
Photo No.
74

Description:
Upstream slope of LSP.

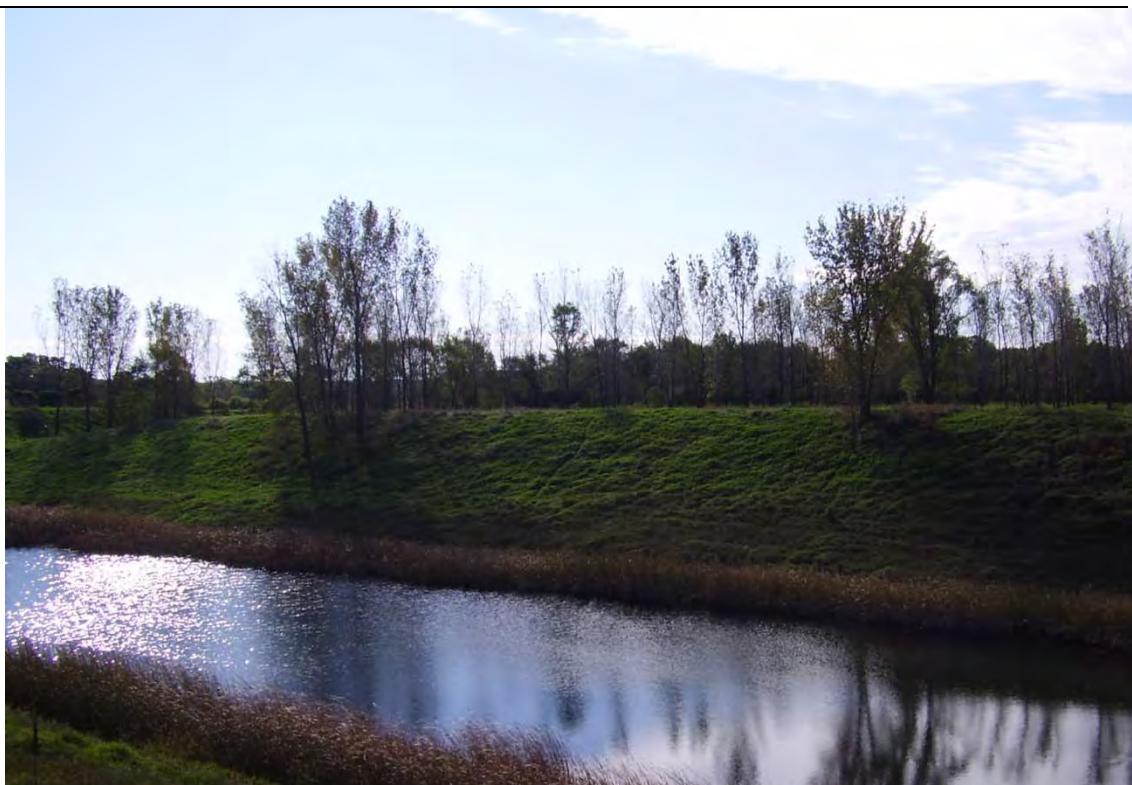
Photo No.
76

Description:
Crest of LSP.

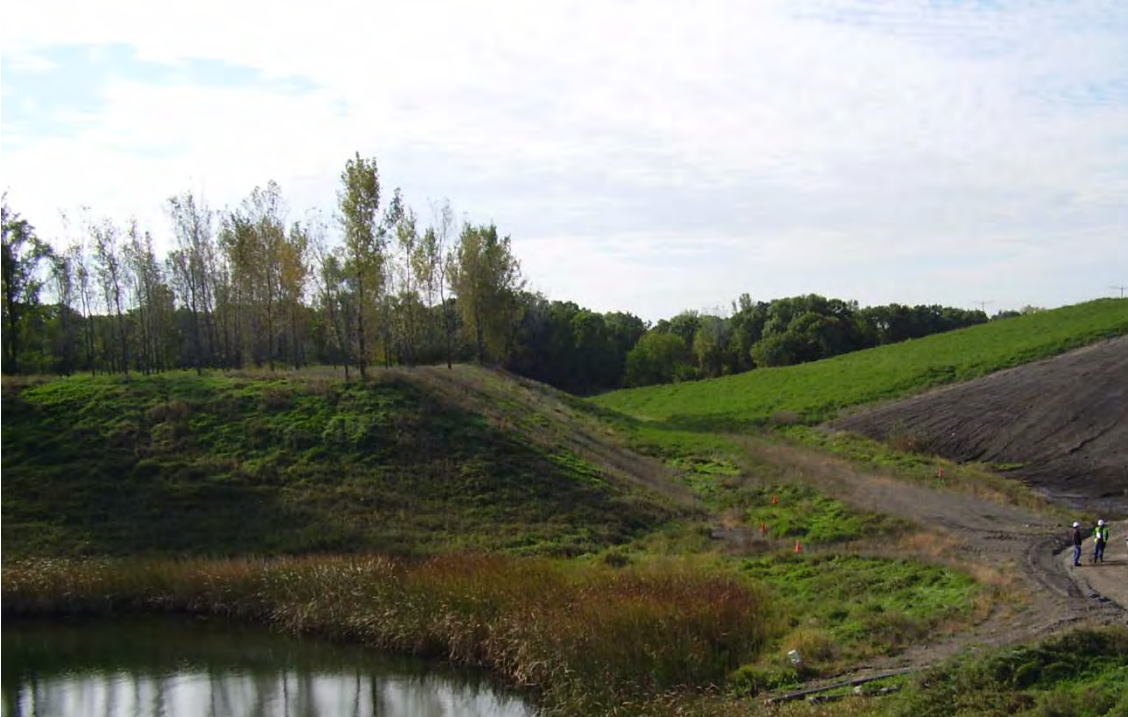
| Description: Upstream slope and crest of LSP. | | | |

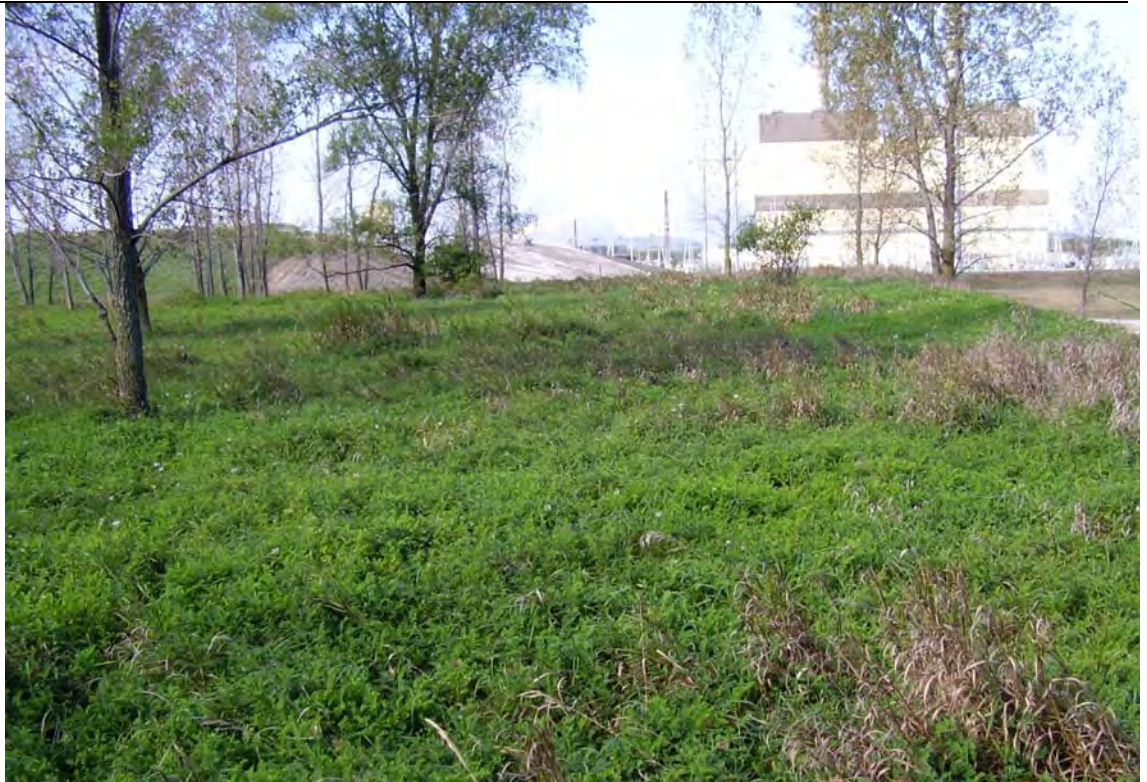
Photo No.
80

Description:
Crest of LSP.

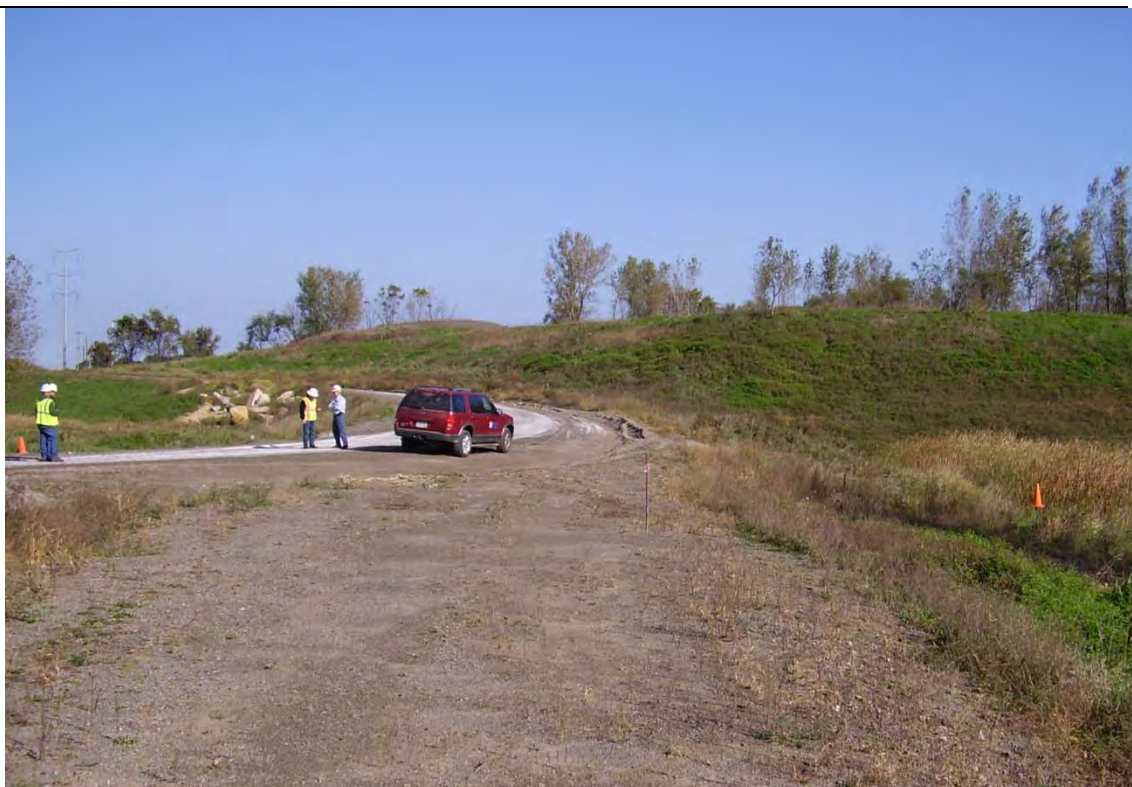
Photo No.
82

Description:
Crest of LSP.

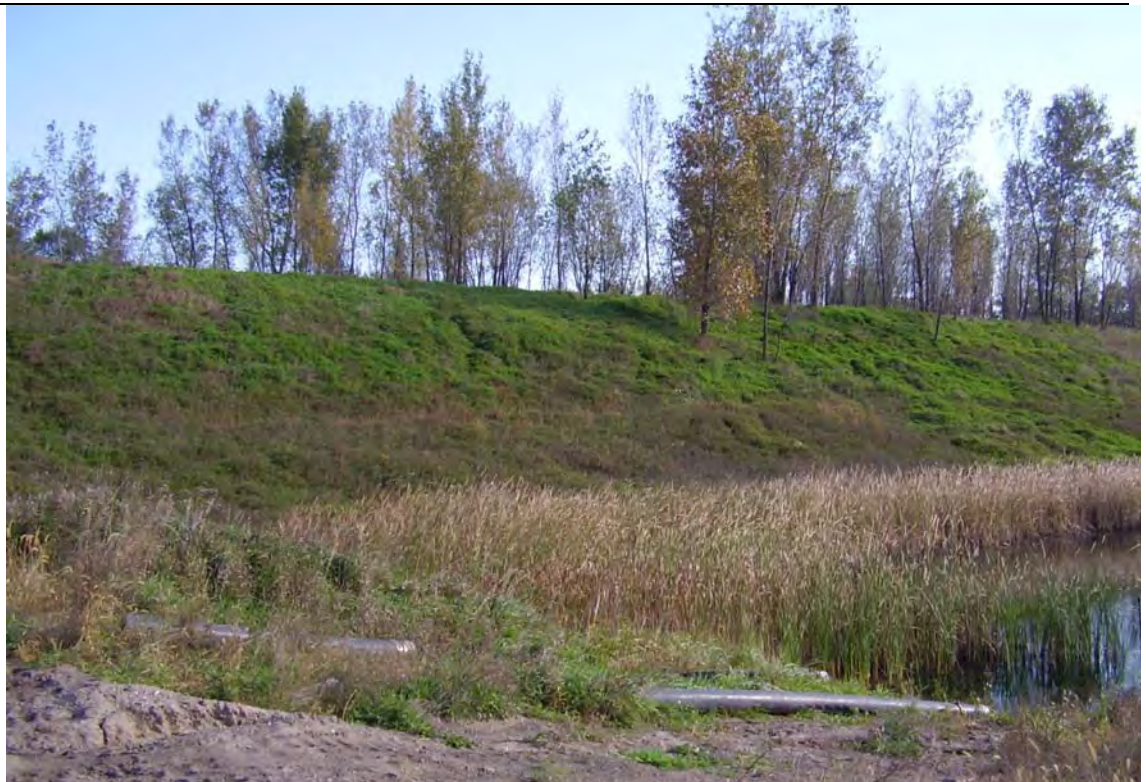
Photo No.
84

Description:
Upstream slope and crest of
PP.

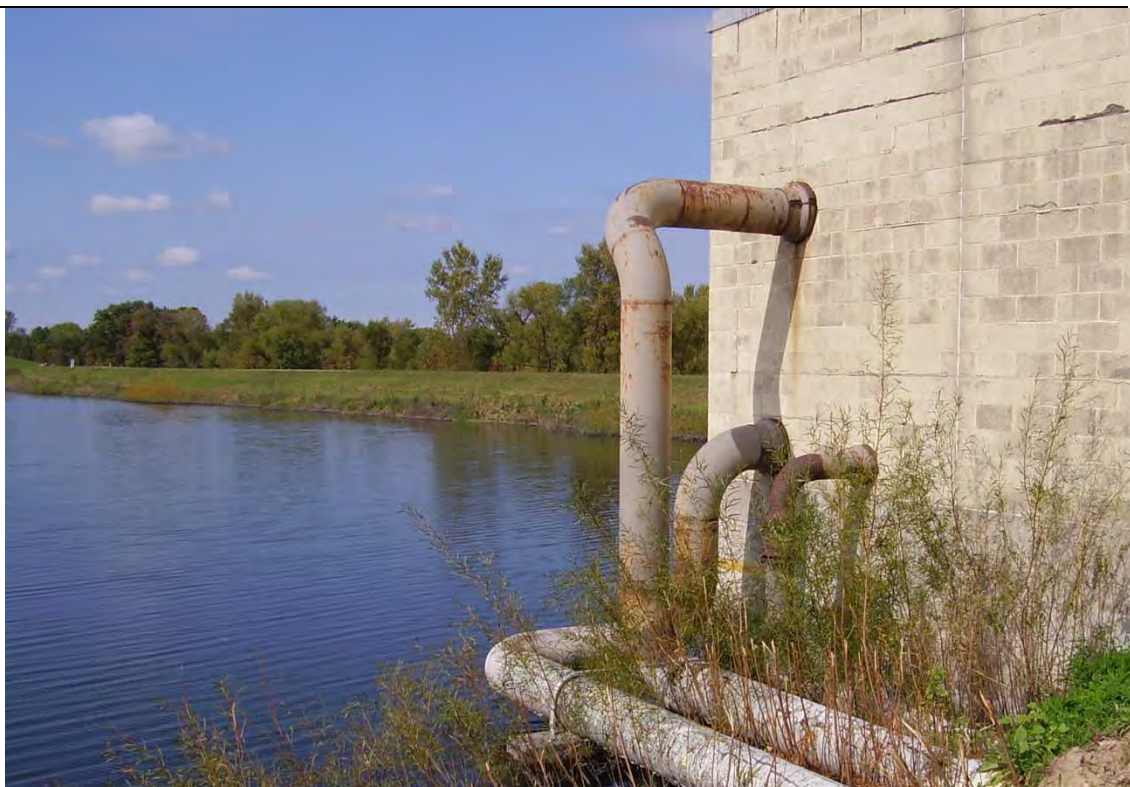
Photo No.
86

Description:
PAP pump house.
